BELZONA SEALS WIND FARM TRANSFORMER

ID: 6351

Customer Location: Wind farm, North Wales
Application Date: January 2016

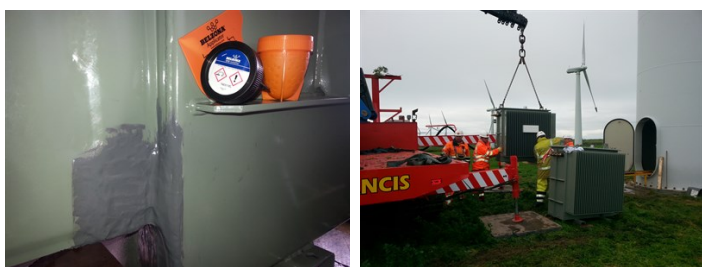
Photograph Descriptions

The transformer was leaking transformer oil. This was a safety concern as the transformer could overheat. The transformer couldnot be transported from siteas the leaking oil could contaminate the surrounding farmland. A quick solution was required to avoid operational delays.

* 1. Belzona 1212 applied to leaking section 2. Transformer being Replaced 3. Belzona 1212 repair made transformer safe before being transported from site ,

The application was carried out in accordance with Belzona KnowHow System Leaflet TCC-1. The surface was prepared using power and hand tools before applying the Belzona 1212 to seal the leak.
