BELZONA ABRASION RESISTANT LINING FOR DE-BARKER

Industry: Pulp & Paper

Application: SHM-Solids Handling Machinery

Customer Location: Paper mill, Poland

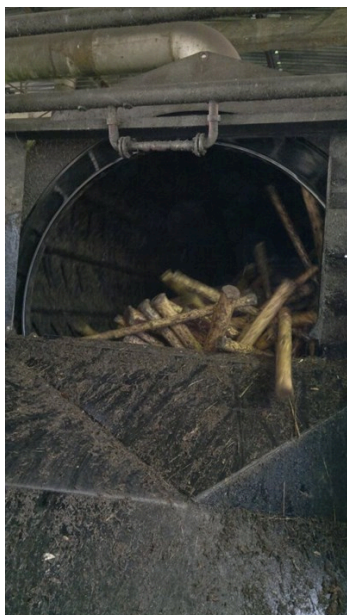
The steel protection plates were wearing away due to severe abrasion. They required a solution to prolong the life of the equipment. If the problem was not resolved during the planned maintenance period, then the customer risked a unscheduled stoppage to the plant and costly downtime.

* 1. De-barkers create a very abrasive environment 2. Surface preparation prior to application 3. Layers of Belzona 1321 and 1811 applied 4. Belzona 1811 lining of de-barker ,
