# BELZONA REBUILDS SECONDARY CHEMICAL CONTAINMENT

ID: 6353

Customer Location: Eastover, SC, USA

Application Date: August 2016

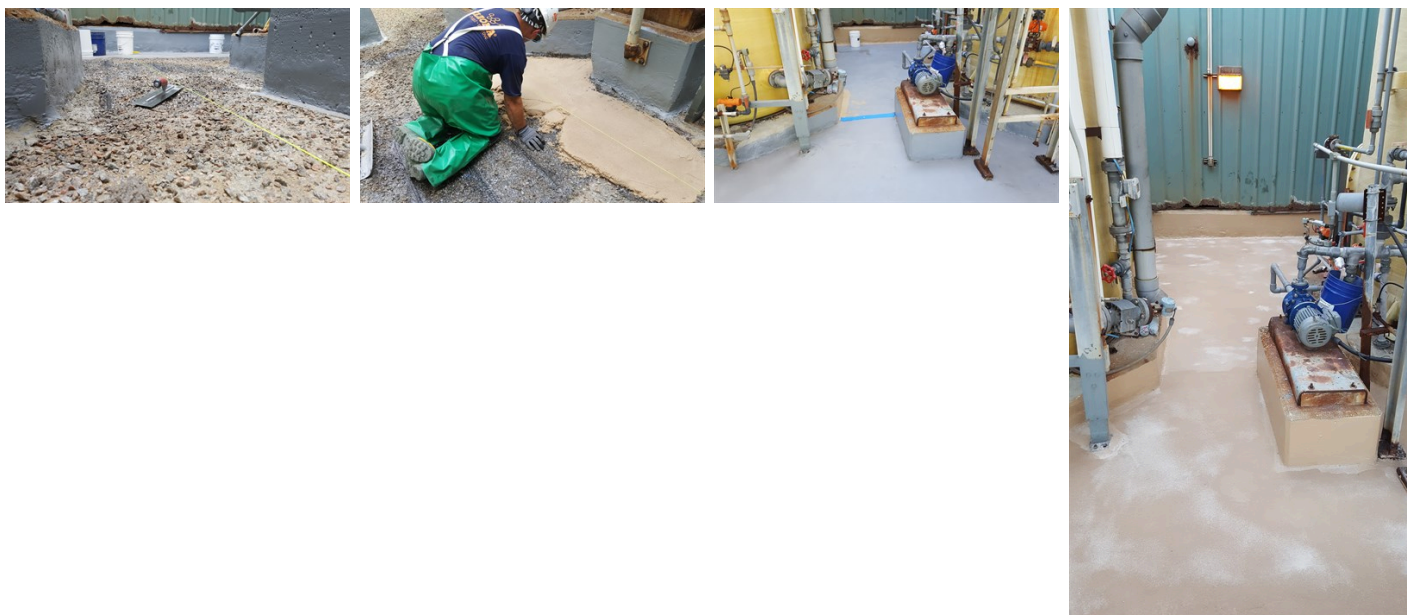
## Photograph Descriptions

Repeated contact with caustic and hydrochloric acid over a period of years had caused serious damage to the concrete floor, tank and pump support bases.

- \* 1. Damaged concrete showing depth below grade. ,
- \* 2. Belzona 4154 being used to fill deeply eroded area. ,
- \* 3. Final grade with Belzona 4131 (Magma-Screed). ,
- \* 4. Final coat with Belzona 5811 and broadcast aggregate. ,

Badly damaged concrete in a caustic and hydrochloric acid secondary containment area at a chemical plant. Both caustic and hydrochloric acid are at 10% concentration and at ambient temperature.

The application was carried out in accordance with Belzona System Leaflets TCC-9 and TCC-15. Damaged and loose concrete was removed and the entire area was high pressure water washed. PH testing was carried out and the area verified neutral after washing. When dry the eroded vertical surfaces of the tank and pump support bases were rebuilt with Belzona 4141 (Magma-Build). The deeply eroded areas of the concrete floor were filled to within approximately 1/4" of the final grade using Belzona 4154 (Bulkfill Resin) and sand. The final grade required for proper drainage was achieved using Belzona 4131 (Magma-Screed). The entire area was protected with Belzona 5811 with a light broadcast coat of aggregate for slip-resistance.
