BELZONA REFURBISHES AND PROTECTS MARINE JET TUBE UNITS

Marine jet tube units

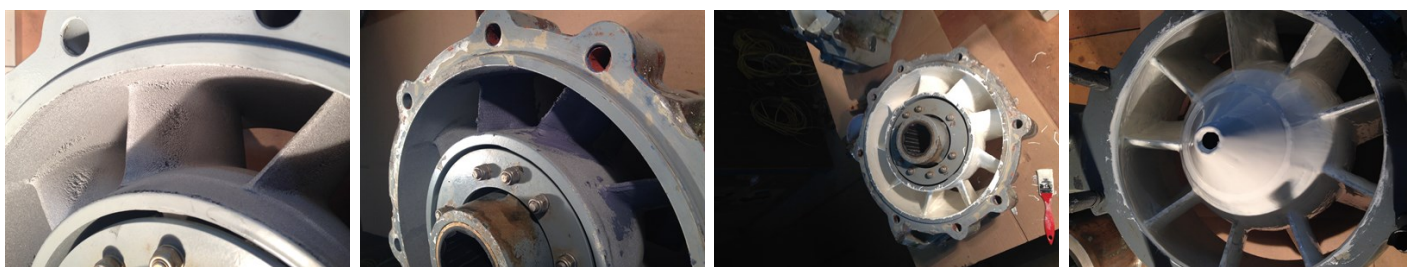
Photograph Descriptions

Jet Tubes were subject to cavitation from constant water flow. Since this type of jet tube units is not manufactured anymore, it was critical for the customer to extend the life of the equipment.

- * 1. Blasted surface and visible cavitation ,
- * 2. Rebuilding the substrate back to its original profile with Belzona 1311. ,
- * 3. Belzona 1331 being applied. ,
- * 4. Completed application ,

After grit blasting and washing the units in a salt away solution to remove embedded salts the units were cleaned with Belzona 9111. Once fully prepped Belzona 1311 was used to fill the cavitated areas, then two coats of Belzona 1331 were brushed on for full protection against further damage.
