BELZONA WEATHERPROOF PROTECTION FOR INSPECTION BOXES

ID: 6362

Industry: Power
Application: GSS-Gaskets, Seals and Shims
Substrate: Steel
Products: * Belzona 1111 (Super Metal) ,
* Belzona 3411 (Encapsulating Membrane) ,

Customer Location: North Wales, UK
Application Date: April, 2016

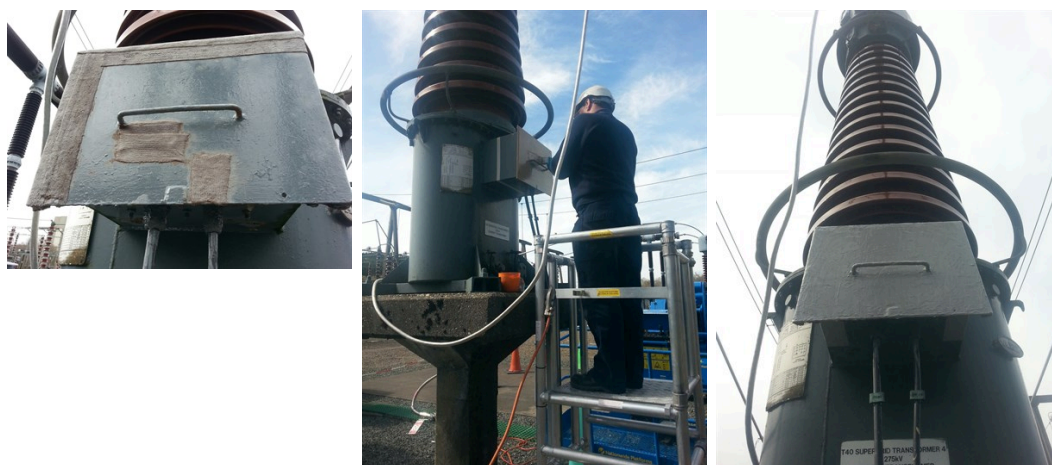
Previous repairs on the boxes had been unsuccessful and close inspection revealed concealed through-wall defects as well as general corrosion damage. The customer wanted a solution that would waterproof the boxes, but could be removed when the switches inside were due for inspection.

* 1. Corroded inspection box 2. Belzona application in action 3. Completed application 4. System revisited after 8 months ,

Corroded inspection box covers at a National Grid site.

The application was carried out in accordance with Belzona Know-How System Leaflets TCC-1 and GSS-11. Holes were repaired by bonding on small metal plates and other areas of corrosion were rebuilt with Belzona 1111 to allow the cover plate to fit correctly. Belzona 3411 system was then applied to seal the cover plate to provide a water-tight seal.

The customer was very happy with the end result. The Belzona repairs ensured a long term solution and the use of the Belzona 3411 made access for inspection to the switches simple. The inspection hatches were revisited 8 months later and the Belzona

solution was found to be in perfect condition.
