BELZONA RESTORED DOCK STEPS GOOD AS NEW AFTER THREE DECADES

ID: 6368

Customer Location: Naval dock, La Spezia, Italy
Application Date: June, 1989

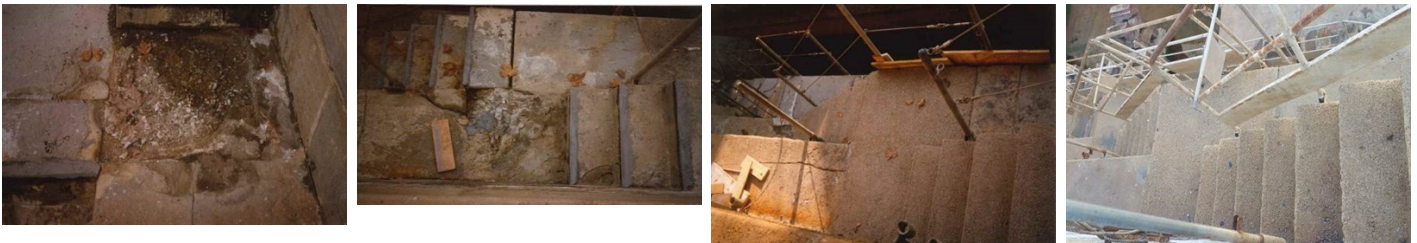
Photograph Descriptions

Access steps showed conspicuous signs of deterioration due to the aggressive marine environment and pedestrian traffic from workers over the decades.

* 1. Deteriorated steps 2. View of the edges during reconstruction 3. Application completed in June 1989 4. View of the same area in September 2016 ,

Application was carried out in accordance with Belzona System Leaflet FPA-1. The damaged area was high-pressure cleaned, manually scarified and rebuilt with Belzona 4111. Belzona 4151 was then applied on top in conjunction with marble chips.

Repair was performed in 1989 and was then inspected in September 2016. After 27 years of service the repaired steps showed no sign of degradation and were in perfect working order.
