# BELZONA PROTECTS AGAINST ACID ATTACK

**Industry:** Chemical & Petrochemical  
**Application:** TCC-Tanks and Chemical Containment Areas

**Customer Location:** Chemical Plant, Cheshire, UK  
**Application Date:** March 2003

Acid waste sump

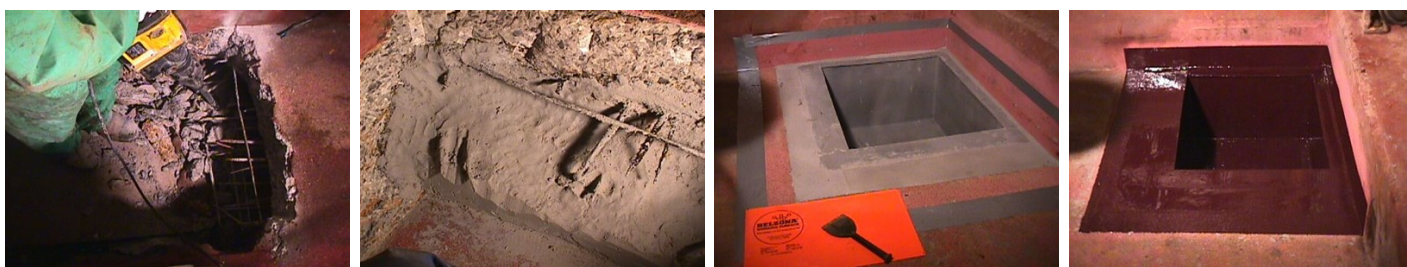
Hydrochloric acid was seeping into a nearby water course. The problem was tracked down to a sump which had a hole in it, hydrochloric acid was leaking through and eating through the underlying concrete.

\* 1. The extent of the problem  
\* 2. Belzona 4111 fills the hole  
\* 3. Sump rebuilt using Belzona 4111  
\* 4. Coated with Belzona 4311 to protect from acid attack ,

Application was carried out in accordance with Belzona System Leaflet TCC-9. Damaged concrete was rebuilt and levelled with Belzona 4111 before coating with Belzona 4311.
