# BELZONA CHANGES THE SHAPE OF COLD PLATE BONDING

ID: 6371

Industry: Oil & Gas  
Application: FBC-Fans, Blowers and Compressors

Customer Location: Gulf of Mexico, USA  
Application Date: August 2016

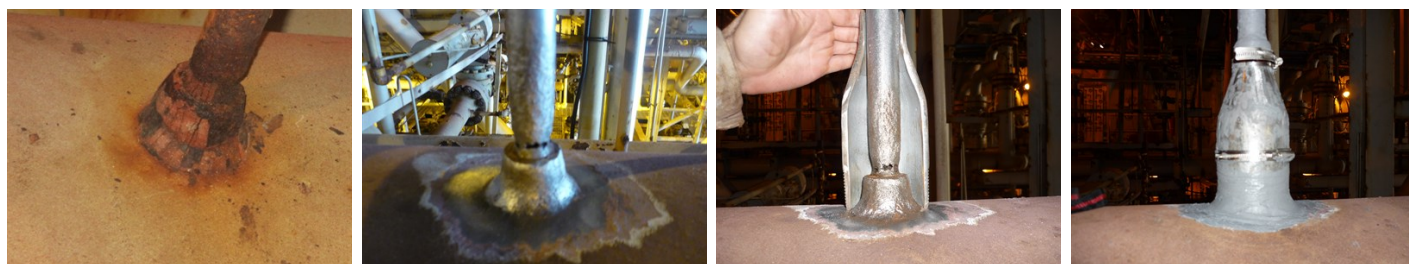
## Photograph Descriptions

The customer had a 1" inlet into a 20" flare line. The threads of the 1" pipe were corroded and holed through. Any gas leaking out would be a major safety hazard.

- \* 1. Corroded inlet before the repair. ,
- \* 2. Inlet after surface preparation. ,
- \* 3. Test fit of plate bonding. ,
- \* 4. Completed cold plate bonding. ,

Offshore production platform had corroded pipe with 80% of structural loss

The application was carried out in accordance with Belzona Know-How System Leaflet FBC-6 for sealing leaks. Application was carried out by scaffolding up to the pipe rack. Surface preparation included Bristle Blasting. 1"-3" reducer was suggested by the contractor and split in half beforehand. Hose clamps were used to hold the repair until fully cured.
