# REGULATORY AGENCY ACCEPTS BELZONA SUPERWRAP II

ID: 6376

Offshore platform with leaking pipe

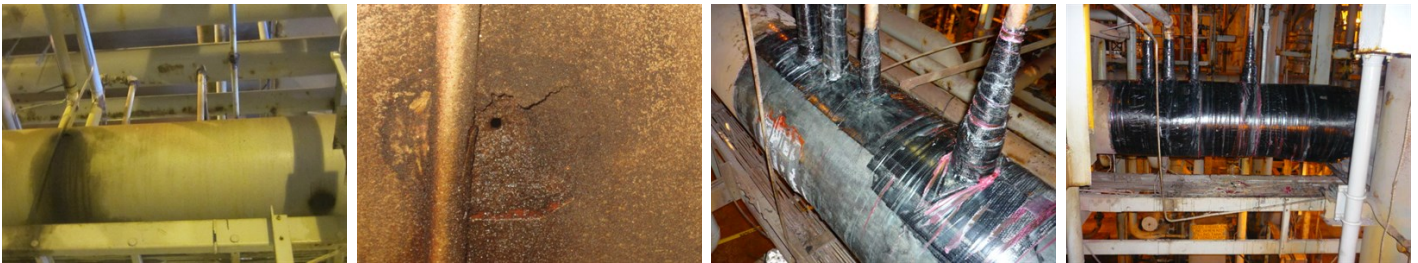
The customer had a section of pipe with external corrosion problems and several through wall defects. Traditional cut and replace alternatives would require costly shutoff of the platform. The entire pipe was welded in place and there were no flanged connections to make a spool swap. An engineered solution was required by the regulatory agency that oversees the platform.

- \* 1. Pipe section showing two leaks. ,
- \* 2. One of the hole-through defects. ,
- \* 3. Super Wrap II is applied to nozzles first. ,
- \* 4. Super Wrap II is applied to larger pipe. ,

The repairs were designed in accordance with ASME PCC 2 standard. The application was carried out by factory trained and validated Installers and Supervisors.

Six feet of 20" pipe was wrapped together with two feet of 1" pipe, and two feet of 3" pipe. Three Belzona Super Wrap II designs were used to address different defect locations, ranging from three to seven wraps.
