Belzona Extends the Life of a Seawater Pipe

ID: 6378

Customer Location: Gulf of Mexico, USA
Application Date: November 2016

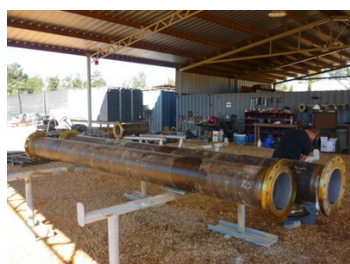
- * Pipes after abrasive blasting. ,
- * Surfaces are degreased prior to application. ,
- * Belzona 1331 internal lining. ,
- * Complete application. ,

These 12" sections of pipe were internally lined by brush and roller due to spin-spray equipment not available. Belzona 1331 was installed in four thin coats with the pipe orientation changing four times.
