BELZONA PRESERVES CONCRETE PILES OFFSHORE

Industry: Oil & Gas
Application: SOS-Ships and Offshore Structures

Customer Location: Gulf of Mexico, USA
Application Date: November 2016

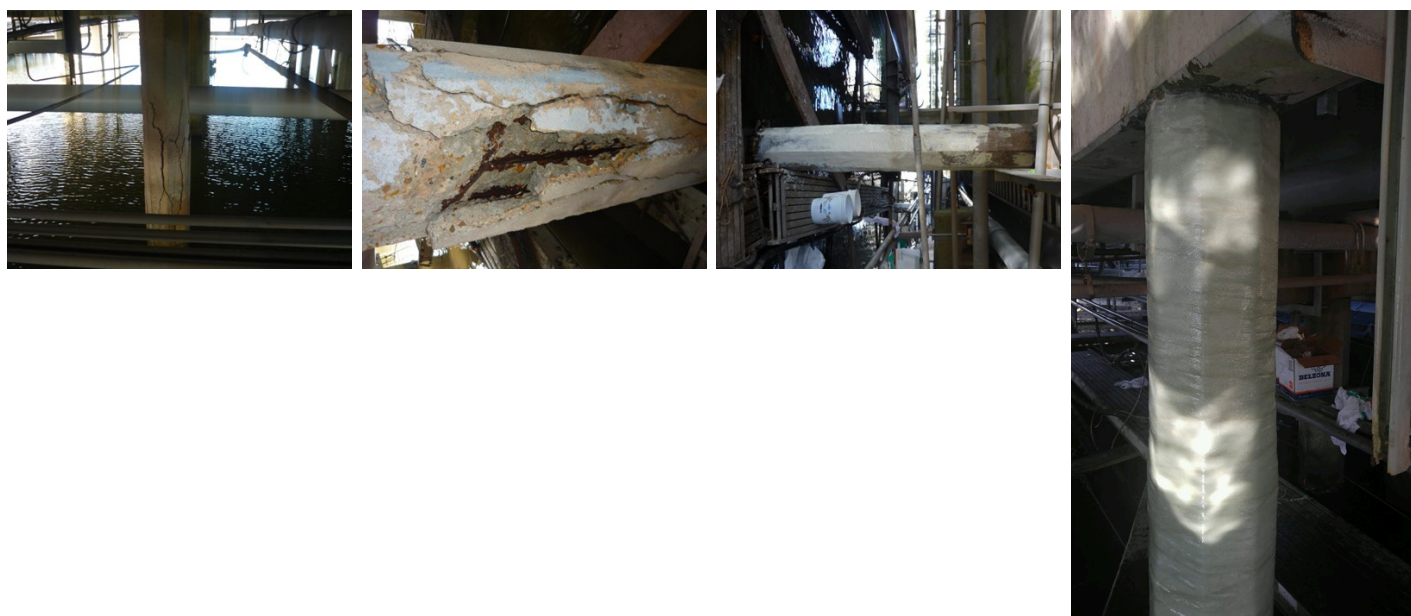
Photograph Descriptions

At an aging facility off the Louisiana coast, a gas lift station is experiencing fractures in their concrete piles under the foundation. Uneven stress causes some piles to bear more load as weight is transferred off other piles.

- * 1. Fractured concrete pile. ,
- * 2. Exposed rebar. ,
- * 3. Pile conditioned with Belzona 4911 and rebuilt with Belzona 4141. ,
- * 4. Pile encapsulated with Belzona 4151/9371 composite wrap. ,

Offshore application. Marshland soil settlement is causing concrete piles to show stress fractures. Exposed rebar is corroding.

Belzona 4141 was used to bulk fill into large cracks and gaps. Belzona 9371 was saturated with Belzona 4151 and used to wrap the rebuilt pile to reinforce.
