BELZONA PRESERVES CONCRETE PILES OFFSHORE

ID: 6379

Industry: Oil & Gas
Application: SOS-Ships and Offshore Structures

Customer Location: Gulf of Mexico, USA
Application Date: November 2016

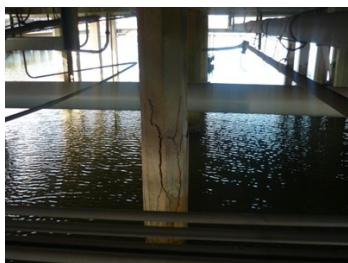
At an aging facility off the Louisiana coast, a gas lift station is experiencing fractures in their concrete piles under the foundation. Uneven stress causes some piles to bear more load as weight is transferred off other piles.

- * 1. Fractured concrete pile. ,
- * 2. Exposed rebar. ,
- * 3. Pile conditioned with Belzona 4911 and rebuilt with Belzona 4141. ,
- * 4. Pile encapsulated with Belzona 4151/9371 composite wrap. ,

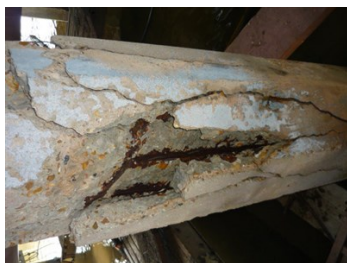
Offshore application. Marshland soil settlement is causing concrete piles to show stress fractures. Exposed rebar is corroding.
