# BELZONA WEATHERPROOFS THE ROOF AND SAVES ELECTRICAL EQUIPMENT ON OFFSHORE PLATFORM

ID: 6381

Industry: Oil & Gas  
Application: SOS-Ships and Offshore Structures

Customer Location: Gulf of Mexico, USA  
Application Date: September 2016

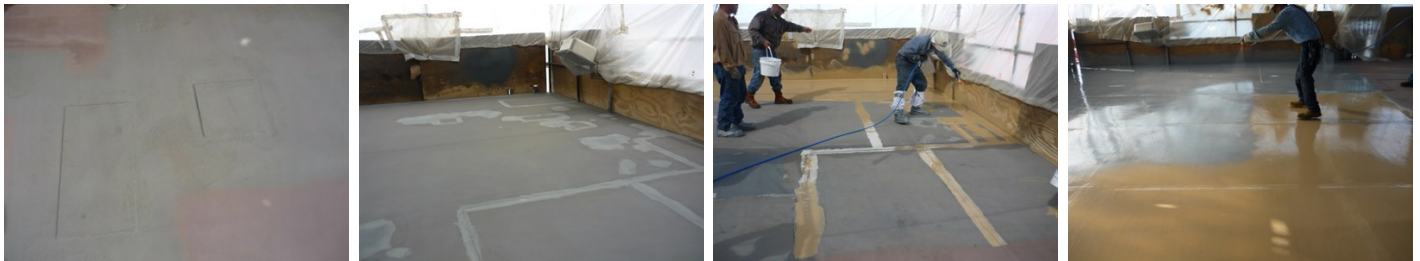
## Photograph Descriptions

Water leaking into a metal building from existing patches on the roof and porous weld seams. Other types of epoxy repairs were tried, but failed due to the harsh offshore weather.

- \* 1. After abrasive blasting some metal patches were loose. ,
- \* 2. Metal plate perimeter and holes sealed with 1121. ,
- \* 3. Spray application of 5811 beige and non-skid aggregate. ,
- \* 4. Spray application of 5111 gray top coat. ,

Metal building with leaking roof on offshore platform. Electrical equipment housings inside building are getting corrosion damage.

Belzona 1121 is used to seal porous welds and fill gaps in existing welded metal patches. Belzona 5811 is used to seal all surfaces. Belzona 5111 is used as a top coat to provide durable weather resistance.
