WASTEWATER VACUUM TRUCK INTERNAL COATING AND REPAIR

ID: 6393

Customer Location: Los Angeles, CA, USA
Application Date: Summer of 2015

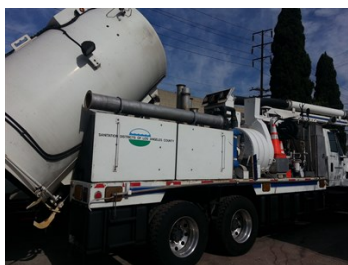
- * External view of the vacuum truck ,
- * View of the damaged internal area ,
- * Belzona 1812 applied to the opening/back opening door ,
- * Belzona 1321 applied to the intake pipework and Belzona 5811 applied to the entire tank ,

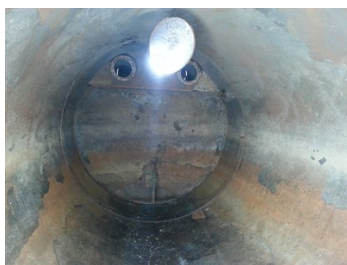
This damage was leading to failures within the intake pipe and corrosion was being found throughout the tank as a whole. If not addressed properly with the correct protection, the tank would eventually run to failure and require replacement.

The wastewater and miscellaneous discharges of sewer compatible wastewater (MISC) were causing the interior of the vacuum trucks of the City of Los Angeles to corrode and become damaged from impact abrasion.
