## Belzona Makes Quick Work of Cleat Repair

ID: 6407

Industry: General Industry  
Application: SHM-Solids Handling Machinery

Substrate: Rubber  
Products: \* Belzona 2311 (SR Elastomer) ,  
\* Belzona 2911 (Elastomer QD Conditioner) ,  
\* ,

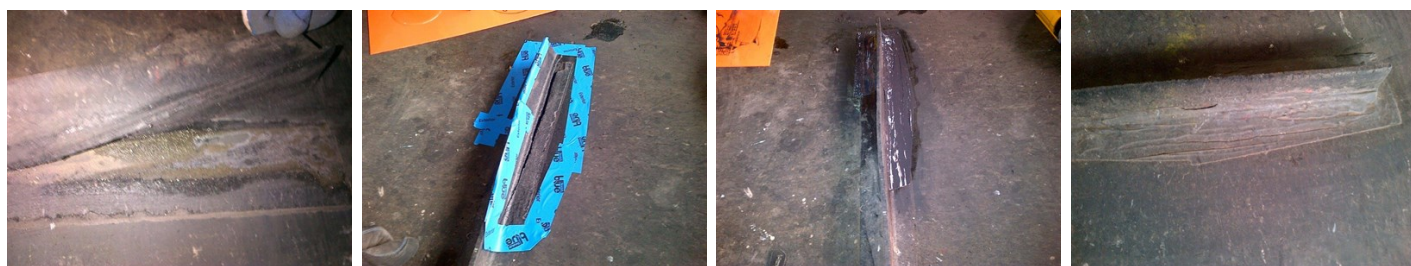
### Photograph Descriptions

Cleat on conveyor belt used to sort materials at a recycling facility was torn and ineffective. The design of the equipment was allowing the conveyor to become clogged and putting more strain on the cleats than the original vulcanization could handle.

\* 1. Damaged cleat <br />2. Repair area cleaned, roughened, and conditioned <br />3. Repair completed <br />4. Repair revisited 8 months later, still performing perfectly ,

The application was carried out in accordance with modified versions of SHM-1 and SHM-5. The area was cleaned and roughened using the Belzona Roughing (Carding) brush to create a woolly finish. Belzona 2911 was used to condition the surface and the edges were taped to keep the repair within the conditioned area. Belzona 2311 was used to bond the cleat back to the belt and used to repair and flash over the torn areas of the cleat.
