# Belzona Provides Solution for Long Time Leak

ID: 6409

Customer Location: Nashville Tennessee Hospital  
Application Date: October 2016

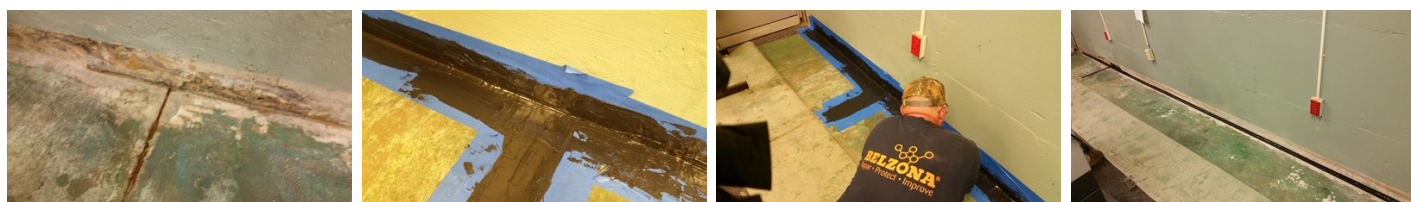
## Photograph Descriptions

Water was leaking into work spaces where the wall meets with the floor. The combination of an ongoing leak and a subterranean work space was creating an unhealthy work environment. The opposite side of the wall was under approximately 30 ft of earth and concrete so they needed a way to repair it from the negative side.

\* 1) Area to be repaired, this joint was where the worst of the leak was 2) Same area with Belzona 2221 in place 3) Application in process 4) Application complete ,

20 feet of basement wall was leaking where it meets with the floor.

Application was carried out using a modified version of Belzona System Leaflet RPA-8. Belzona 2221 was selected as an alternative to a Belzona 3000 series product due to the fact that there was potential for a build up in head pressure behind the leak. Work was delayed until there was a dry spell and the application area was free of moisture. Application area was prepped using a concrete grinding disc and loose dust and debris was cleaned up. The area was then conditioned with Belzona 2911 and edges were taped to contain the repair to the conditioned area. Belzona 2221 was applied as a flashing that would stop moisture while simultaneously allowing for movement of the wall and floor.

Efforts to caulk the joint didn't provide a lasting solution. With each small movement in the wall, previous repair attempts had failed. They needed a 100% solids material that wouldn't shrink over time and could withstand the movement. After a very wet fall and winter, Belzona has proven to be the solution they were looking for.
