# BELZONA BULKFILL USED ON LOADING BAY

ID: 6417

**Industry:** General Industry  
**Application:** FPA-Floor Problem Areas  
**Substrate:** Concrete  
**Products:** \* Belzona 4154 (Bulkfill) ,  
\* Belzona 4111 (Magma Quartz) ,  
\* Belzona 4411 (Granogrip) ,

**Customer Location:** Plasterboard manufacturer, Poland  
**Application Date:** December 2016

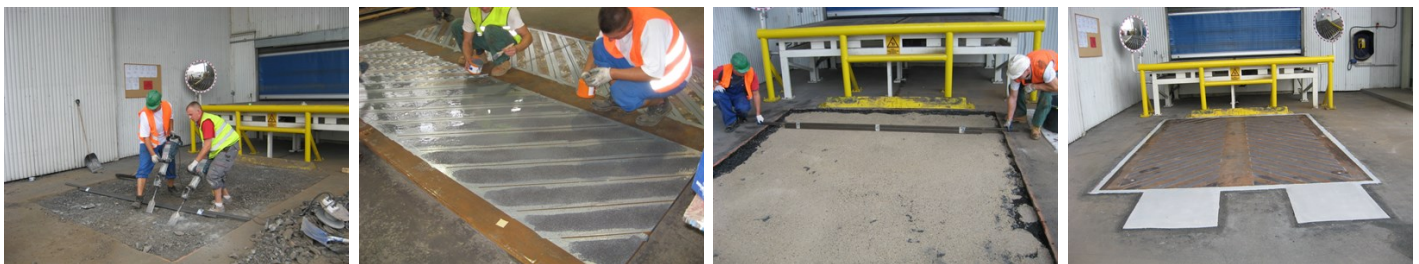
## Photograph Descriptions

Regular loading and unloading caused severe wear to the surface of the loading bay. A cost effective solution to this ongoing problem was required.

\* 1. Chipping away the existing asphalt 2. Applying Belzona 4411 Grip System to steel plate 3. Applying Belzona 4154 to the large area 4. Completed application ,

Application was carried out in accordance with Belzona System Leaflets FPA-1, 2 & 8. After chipping away the damaged asphalt with pneumatic tools, the area was cleaned and prepared, followed by Belzona 4154 to bulk out the area. Belzona 4111 was then used to level the surface and to secure steel plates, previously coated with Belzona 4411 grip system.
