# BELZONA STOPS THAT SINKING FEELING

Industry: General Industry  
Application: SOS-Ships and Offshore Structures

Customer Location: Sand Pit Wichita, Kansas  
Application Date: July 2004

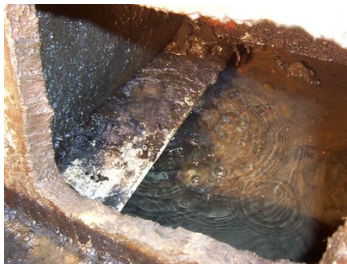
*The hull was leaking in several areas of this sand dredge. If the electricity failed when the plant was unattended the vessel could sink into 30 feet of water.*

- \* Leak in the hull ,
- \* Cutting magnetic sign material ,
- \* Divers positioning signs to stem the leak ,
- \* Leak stopped with Belzona® 1111 ,

Application carried out in accordance with Belzona Know-How System Leaflet SOS-20. Divers placed magnetic sign material over the leaks. This stopped the flow of water while the surface crew dried, cleaned and prepared the area. Belzona® 1111 with Belzona® Reinforcement Tape was applied to the area.
