# BELZONA STOPS THAT SINKING FEELING

Industry: *General Industry*  
Application: *SOS-Ships and Offshore Structures*

Customer Location: *Sand Pit Wichita, Kansas*  
Application Date: *July 2004*

## Problem

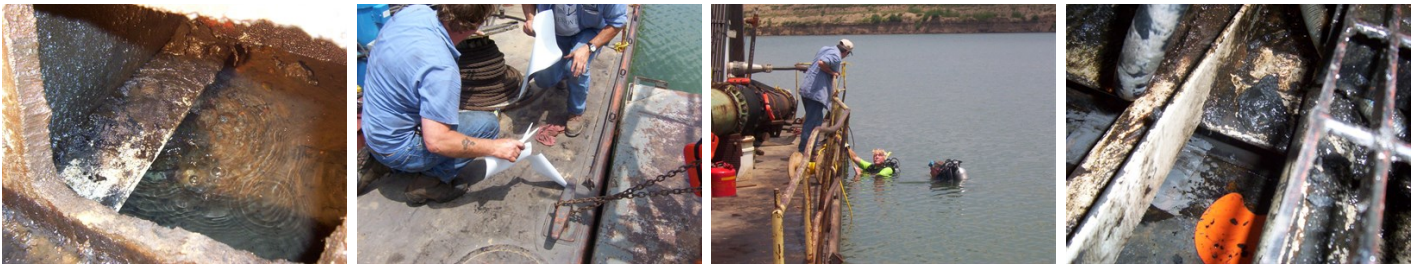
## Photograph Descriptions

*The hull was leaking in several areas of this sand dredger. If the electricity failed when the plant was unattended the vessel could sink into 30 feet of water.*

- \* Leak in the hull ,
- \* Cutting magnetic sign material ,
- \* Divers positioning signs to stem the leak ,
- \* Leak stopped with Belzona® 1111 ,

Application carried out in accordance with Belzona Know-How System Leaflet SOS-20. Divers placed magnetic sign material over the leaks. This stopped the flow of water while the surface crew dried, cleaned and prepared the area. Belzona® 1111 with Belzona® Reinforcement Tape was applied to the area.
