BELZONA STOPS THAT SINKING FEELING

ID: 642

Industry: General Industry
Application: SOS-Ships and Offshore Structures

Floating sand dredger

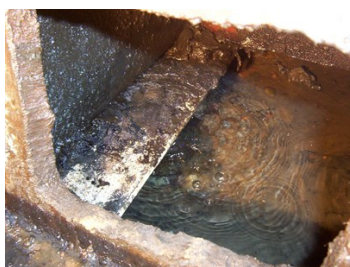
The hull was leaking in several areas of this sand dredge. If the electricity failed when the plant was unattended the vessel could sink into 30 feet of water.

- * Leak in the hull ,
- * Cutting magnetic sign material ,
- * Divers positioning signs to stem the leak ,
- * Leak stopped with Belzona® 1111 ,
