# BELZONA EXTENDS THE LIFE OF SLURRY PUMP CASINGS

**Industry:** Mining & Quarrying  
**Application:** CEP-Centrifugal Pumps  
**Substrate:** Carbon Steel  
**Products:** \* Belzona 1311 (Ceramic R-Metal) ,

**Customer Location:** Copper Mining Company, Bulgaria  
**Application Date:** February, 2016

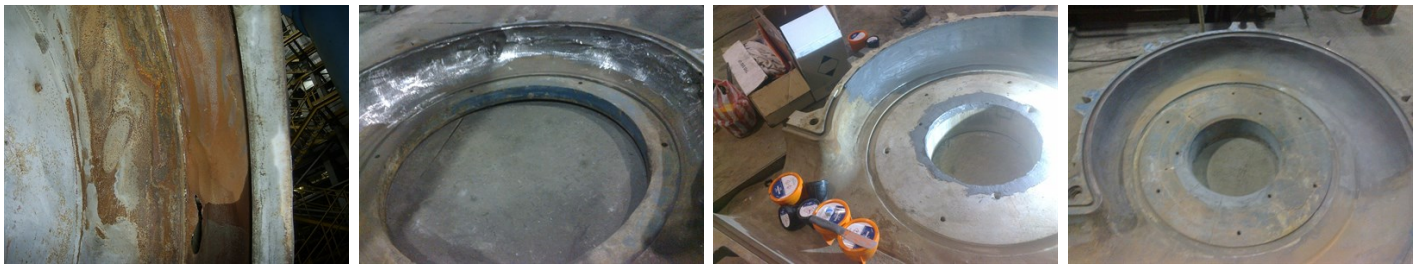
*The casings were badly worn, even through the whole thickness in some places.*

- \* General view of casing before repair ,
- \* Manual preparation of repaired surfaces ,
- \* Application in progress ,
- \* Final view of completed application. ,

The application was carried out in accordance with Belzona Know-How System Leaflet CEP-5. Surfaces were mechanically abraded. Then all pitting and damage was filled with Belzona 1311 and when cured the surfaces were smoothed by grinding.
