BELZONA CORROSION PROTECTION FOR CO2 ABSORBER TOWER

ID: 6424

Customer Location: Nitrogen Fertilizer Plant, Bulgaria
 Application Date: August 2014

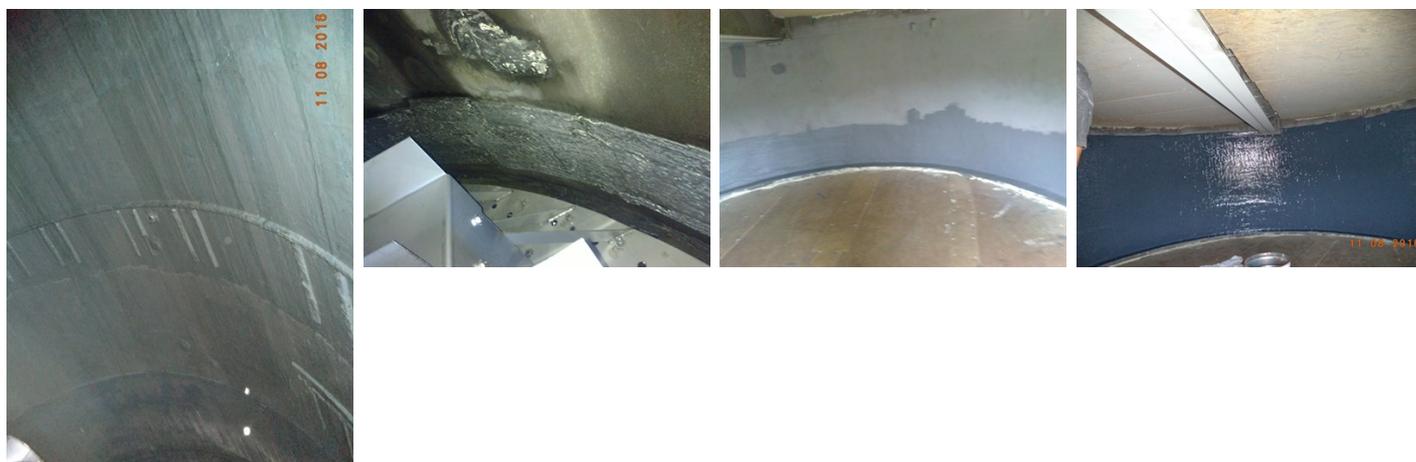
Photograph Descriptions

Significant defects of the inner walls and the bottom of the absorber due to corrosion and erosion in the presence of aggressive chemicals such as MDEA & MEA at elevated temperatures (80-100°C).

- * 1. Inspection in 2016 of the lining applied in 2014 ,
- * 2. View of the pad welded defect areas ,
- * 3. View of repair with Belzona 1311 ,
- * 4. The final application with Belzona 1391 ,

The applications were carried out in accordance with Belzona Know-How Leaflet TCC-3. The customer pad welded deeply pitted areas. Less damaged areas were filled and smoothed with Belzona 1311 before coating with Belzona 1391.

The process tower had worked previously without internal lining until the discovery of major erosion / corrosion defects. The first application of Belzona was carried out in 2014 and the condition was inspected every year. The last inspection in 2016 has reported no degradation of Belzona lining.
