BELZONA CORROSION PROTECTION FOR CO2 ABSORBER TOWER

ID: 6424

Customer Location: Nitrogen Fertilizer Plant, Bulgaria
Application Date: August 2014

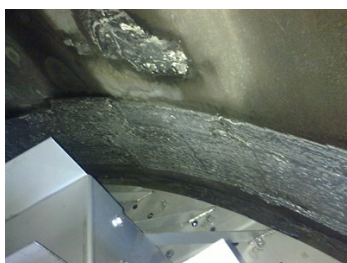
Significant defects of the inner walls and the bottom of the absorber due to corrosion and erosion in the presence of aggressive chemicals such as MDEA & MEA at elevated temperatures (80-100°C).

- * 1. Inspection in 2016 of the lining applied in 2014 ,
- * 2. View of the pad welded defect areas ,
- * 3. View of repair with Belzona 1311 ,
- * 4. The final application with Belzona 1391 ,

The applications were carried out in accordance with Belzona Know-How Leaflet TCC-3. The customer pad welded deeply pitted areas. Less damaged areas were filled and smoothed with Belzona 1311 before coating with Belzona 1391.
