# BELZONA REBUILDS WORN STONE STEPS

**Industry:** Buildings & Structures  
**Application:** FPA-Floor Problem Areas  
**Substrate:** Stone  
**Products:** \* Belzona 4111 (Magma Quartz) ,

**Customer Location:** Prestigious school, Floriana, Malta  
**Application Date:** December 2016

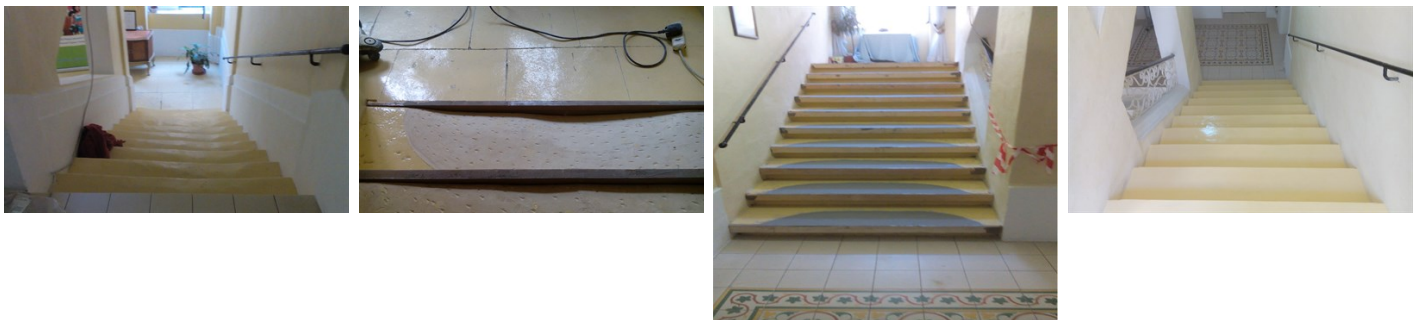
*All the stone steps had become badly worn, uneven and sloping towards the front. This was a safety hazard. Due to the construction of the stone steps, it was not possible to repair with other traditional methods.*

- \* 1. Badly worn stone steps ,
- \* 2. Cleaned and Wooden formers installed ,
- \* 3. Steps filled up and leveled with Belzona 4111 ,
- \* 4. Finished Job ,

The application was carried out in accordance with Belzona Know-How System Leaflet FPA-1. Wooden formers were installed to help level the steps evenly.
