# BELZONA REPAIRS A RESTAURANT ROOF

ID: 6427

Industry: *Buildings & Structures*  
Application: *RPA-Roof Problem Areas*

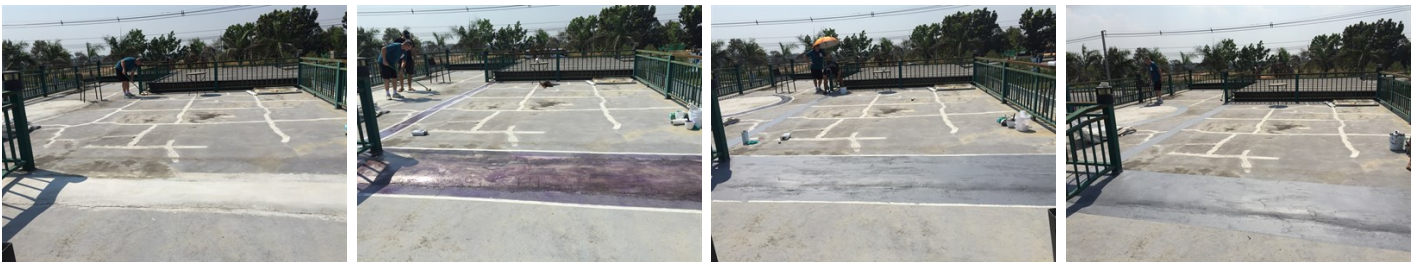
## Photograph Descriptions

*A restaurant with a concrete roof had several areas where water penetrated through inside of the building every time it rained. The problem areas had been repaired with additional concrete but the water still leaked through.*

- \* 1. Surface Preparation ,
- \* 2. Applying Belzona 3911 (PSC Surface Conditioner) ,
- \* 3. Application of Belzona 9311 Reinforcement Sheet wetted out with Belzona 3111 ,
- \* 4. Complete application ,

The application was carried out in accordance with Belzona System Leaflet RPA-1. The area was made clean, firm and dry prior to application. Problem areas were masked off and Belzona 3911 was applied. Once touch dry, Belzona 9311 Reinforcement Sheet wetted out with Belzona 3111 was applied. Finally, a top coat of Belzona 3111 was applied to complete the system.
