# GASSIFIER MIXER BLADES PROTECTED WITH BELZONA

ID: 643

Customer Location: *Refinery El Dorado, Kansas*  
Application Date: *April 2004*

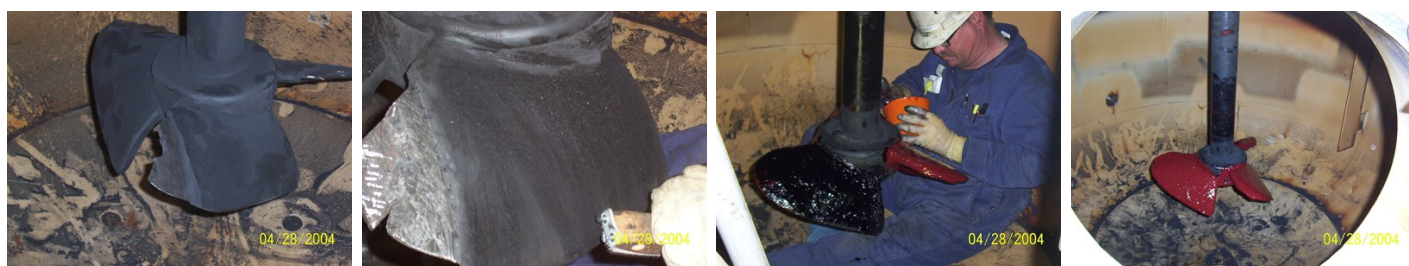
## Photograph Descriptions

*The original rubber coating failed. The leading edge of the steel wore away and large chunks of steel were missing. This decreased the efficiency of the unit.*

- \* Damaged Gasifier mixer blade leading edge missing ,
- \* New leading edge welded and rubber being prepared ,
- \* Application of Belzona® 2121 ,
- \* Finished application ,

Application was carried out in accordance with Belzona Know-How System Leaflet SHM-9.
