EASY LINTEL REPAIR WITH BELZONA

ID: 6435

Application: *WPA-Wall Problem Areas*

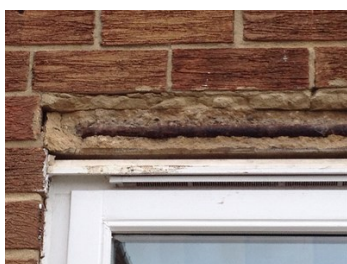
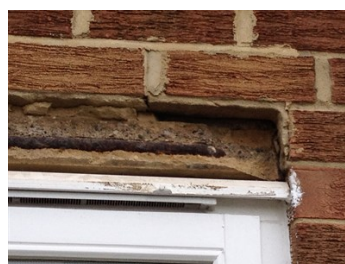
The entire front face of the concrete "Boot" lintel had failed due to re-bar corrosion. The customer wanted a long-term solution without having the need to disturb the structure.

- * 1. Overview (after repair) ,
- * 2 & 3. Damaged Lintel ,
- * 4. Completed repair ,

Application carried out in accordance with Belzona system leaflet WPA-4

The application was completed in just 2 hours. Conventional replacement would have been costly, time consuming and disruptive. The customer has used Belzona 4141 before and is very happy with the results.
