BELZONA SECURES TOWER BLOCK

Application: WPA-Wall Problem Areas

Customer Location: Housing Association, Cleveland, UK

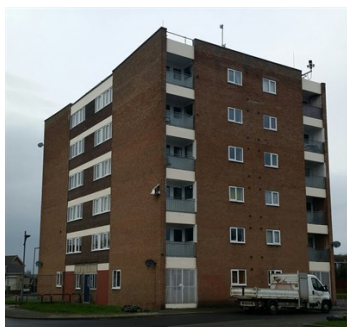
Carbonation of the concrete had caused severe spalling threatening the structure of the balconies and creating a risk of falling debris.

- * 1. Overview of completed work. ,
- * 2. Typical damage. ,
- * 3. Belzona 4141 Application in progress. ,
- * 4. Panel completed after coating with Belzona 5151 ,

Application carried out in accordance with Belzona system leaflet WPA-4 for the concrete repairs and WPA-1 for the Belzona 5151 anti-carbonation coating.
