# BELZONA SECURES TOWER BLOCK

**Industry:** Buildings & Structures  
**Application:** WPA-Wall Problem Areas  
**Substrate:** Concrete and Steel  
**Products:** \* Belzona® 4141 (Magma Build) ,  
\* Belzona® 5151 (Hi-Build Cladding) ,

**Customer Location:** Housing Association, Cleveland, UK  
**Application Date:** 2016

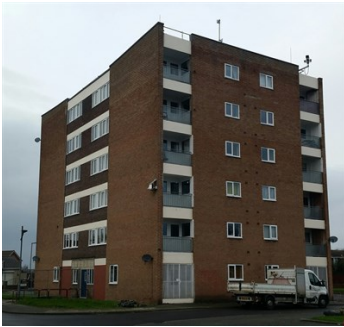
- \* 1. Overview of completed work. ,
- \* 2. Typical damage. ,
- \* 3. Belzona 4141 Application in progress. ,
- \* 4. Panel completed after coating with Belzona 5151 ,

Application carried out in accordance with Belzona system leaflet WPA-4 for the concrete repairs and WPA-1 for the Belzona 5151 anti-carbonation coating.

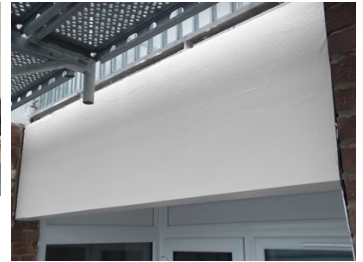
Carbonation of the concrete had caused severe spalling threatening the structure of the balconies and creating a risk of falling debris.
