Belzona Rebuilds Shaft During Wind Turbine Maintenance

ID: 6437

Industry: Power

Application: MPT-Mechanical Power Transmission

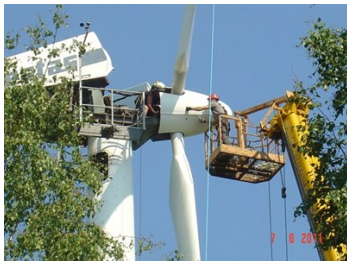
- * 1. Crane access required to maintain the nacelle ,
- * 2. Nacelle removed for routine inspection and maintenance ,
- * 3. Corroded shaft ,
- * 4. Shaft rebuilt using self-lubricating Belzona 1131 ,

Application was carried out in accordance with Belzona System Leaflet MPT-2. A former was used to mould Belzona 1131 to correct dimensions.

Belzona 1131 possesses self-lubricating properties for creation of low friction surfaces in the event of lubrication loss. The product is also corrosion resistant. This made it the ideal solution for the shaft repair. This application is still in service as of 2017.

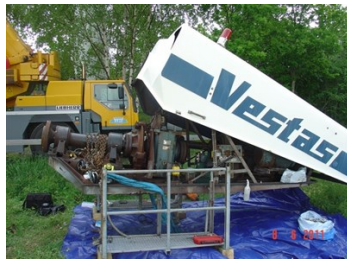
During maintenance of the turbine at a small wind farm, the nacelle was removed in order to inspect the internal components.

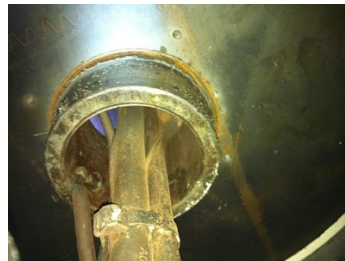
Inspection revealed that the nacelle had suffered from water ingress and the yaw drive shaft was experiencing damage due to corrosion and wear due to lack of lubrication.
