FULL PROTECTION OF DEHYDRATOR WITH BELZONA LINING AND NOZZLE INSERTS

ID: 6449

Customer Location: Oil & Gas Asset Owner, China
Application Date: December 2016

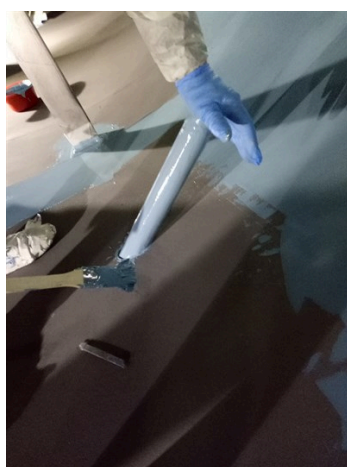
- * 1.Grit blasting to Near White Metal cleanliness levels ,
- * 2. Placing the nozzle inserts ,
- * 3. Application of the second coat ,
- * 4. Inspecting for holidays or discontinuities via spark testing ,

Application was carried out in accordance with Belzona Know-How System Leaflet TCC-5 and TCC-16b . Pre-formed nozzle inserts were fabricated and bonded into small bore nozzles to ensure continuity of protection.
