# FULL PROTECTION OF DEHYDRATOR WITH BELZONA LINING AND NOZZLE INSERTS

ID: 6449

Customer Location: Oil & Gas Asset Owner, China  
Application Date: December 2016

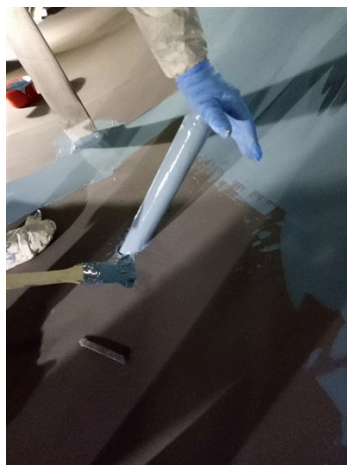
- \* 1. Grit blasting to Near White Metal cleanliness levels ,
- \* 2. Placing the nozzle inserts ,
- \* 3. Application of the second coat ,
- \* 4. Inspecting for holidays or discontinuities via spark testing ,

Application was carried out in accordance with Belzona Know-How System Leaflet TCC-5 and TCC-16b . Pre-formed nozzle inserts were fabricated and bonded into small bore nozzles to ensure continuity of protection.
