# BELZONA RECLAIMS DAMAGED BOWLING ALLEY SIDEPLATE

Customer Location: *Bowling Centre, Calgary, Alberta, Canada*

Application: *WPA-Wall Problem Areas*

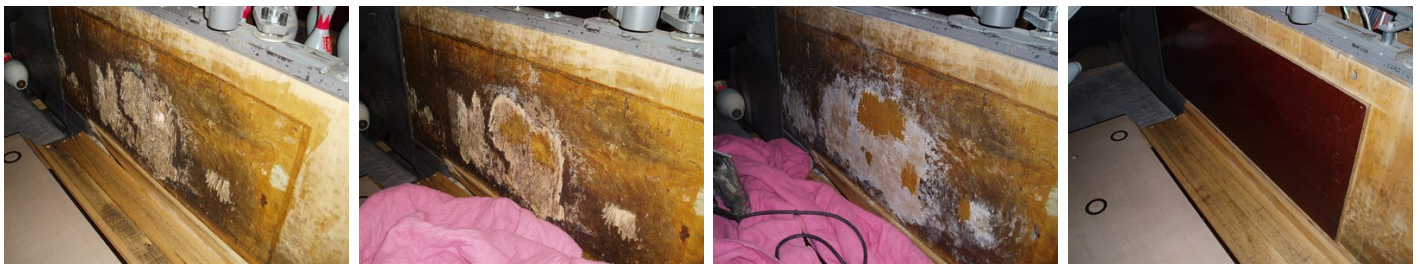
- \* Damaged hardwood slab, 3/4-inch deep ,
- \* First layer of Belzona® 8111 applied ,
- \* Final layer of Belzona® 8111 after sanding ,
- \* Kick plate reinstalled over damaged area ,

Damaged side plate on the pin deck

The method used was similar to rebuilding pitting corrosion on vertical vessel walls, a modified Belzona Know-How System Leaflet TCC-5.
