Belzona Repairs and Protects Screw conveyor

ID: 6459

Customer Location: Wastewater Treatment Plant, Bialystok
Poland

Application: SHM-Solids Handling Machinery

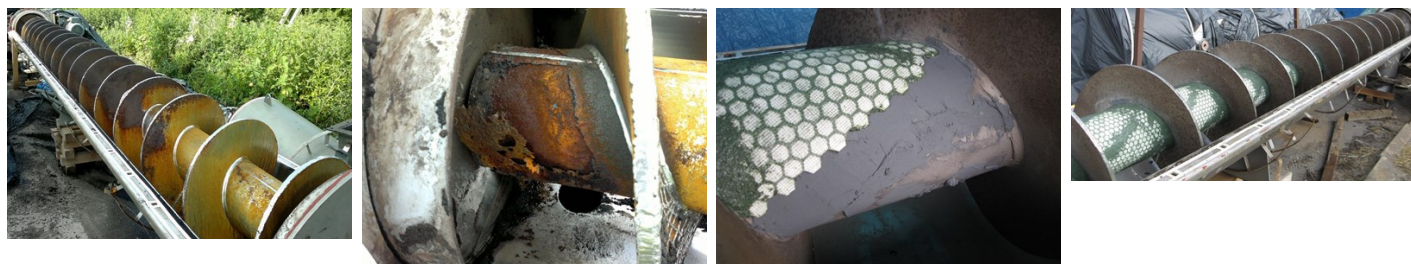
Photograph Descriptions

The new screw conveyor suffered surprisingly fast wear by erosion and bi-metallic corrosion. The shaft of the screw conveyor had been topped with a stainless steel sheet to protect it from corrosion. However, after less than a year of operation the steel was worn from the surface of the shaft. In addition to the aggression of chemical sludge, it reaches a very high temperature of approx. 120 degrees Celsius.

- * 1.Screw conveyor before application ,
- * 2.Visible effects of galvanic corrosion ,
- * 3.Application of Belzona 9811 and Belzona 1511 ,
- * 4.View after grouting with Belzona 1813 ,

The application was carried out in accordance with Belzona System leaflet SHM-14. The surface of the shaft was blasted and Belzona 9811 tiles were bonded to the surface of the shaft using Belzona 1511. The tiles were grouted using Belzona 1813.

The Belzona solution eliminated the problem of galvanic corrosion and increased the durability of the screw conveyor. With Belzona

the life time is three times longer than the original solution.
