BELZONA REPAIR TO GAS BREAKER

ID: 647

Customer Location: Electrical utility in Oklahoma
Application Date: November 2005

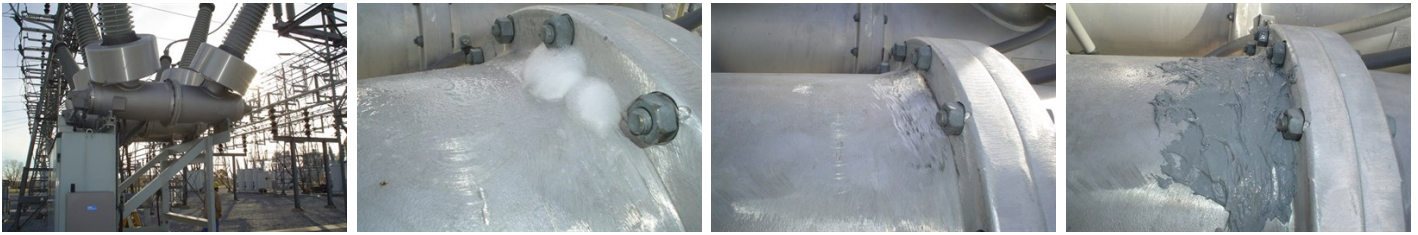
Photograph Descriptions

Gas was quickly escaping and the utility had to send maintenance crews to refill the breaker every 2 weeks so that it would not lock-out.

- * The breaker leaking gas ,
- * Soapy water sprayed to detect location of leak ,
- * Area prepared for application by grinding ,
- * Completed repair soaked in soapy water to ensure no leaks ,

Application was carried out according to Belzona Know-How System Leaflet VPF-11a.
