# BROKEN INSULATORS REPAIRED WITH BELZONA

ID: 649

Customer Location: Power plant , Egypt.  
Application Date: October 2005.

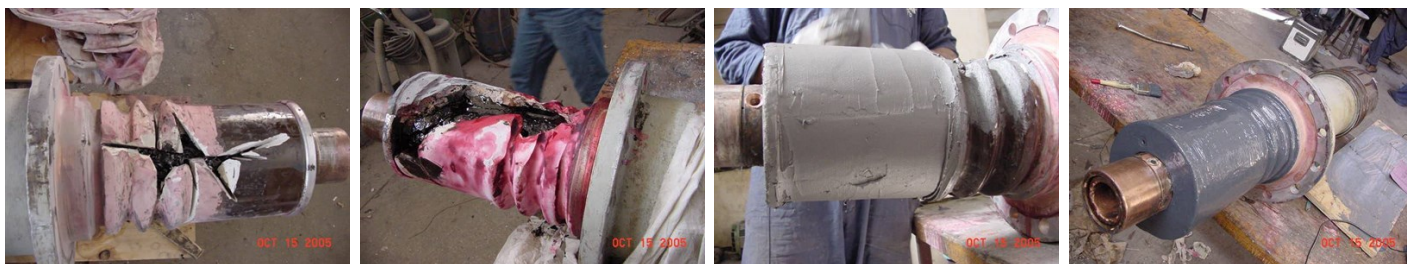
Two Insulators were cracked and broken. Also the copper pipe inside one of them was broken.

- \* The broken Insulator. ,
- \* The second Insulator. ,
- \* Belzona® 1111 was applied to fill the cracks and broken areas. ,
- \* Repaired Insulator. ,

Application was carried out in accordance with modified Belzona Know-How system leaflets VPF-1 & VPF-2. Original profiles were restored with Belzona® 1111 and smooth top surface created using Belzona® 1391.

Belzona perfectly repaired the badly broken Insulators saving the costs of new units beside the long import time. After the repair the dry resistance of the insulators was measured and found to be about 5000 mega ohm which was much higher than the normal resistance of the old insulators.
