# BELZONA BALL MILL BEARING PLATE

Customer Location: Coal Fired Power Plant in Alabama

Coal pulverizer-ball mill bearing plate

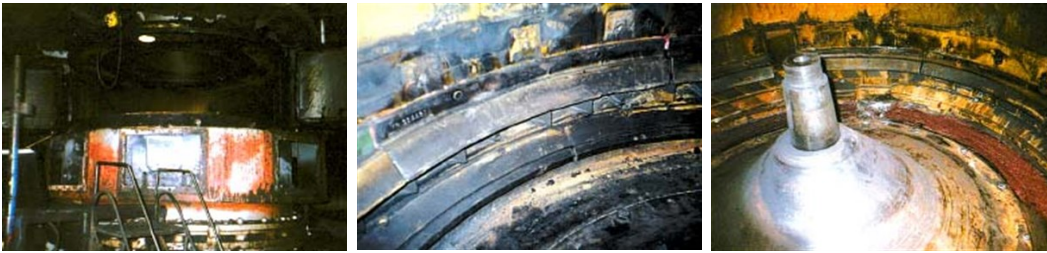
Coal fines cause wear behind the bearing plate resulting in holes and allowing coal to drop out of the pulverizer.

- \* Outside view of the coal pulverizer. ,
- \* Holes behind bearing plate of ball mill. ,
- \* Holes sealed, Belzona® 1811 in place. ,

The application was carried out in accordance with Belzona Know-How Leaflet SHM-7.

The use of Belzona saves the plant \$20,000 in replacement cost for the bearing plate and also saves one week downtime. Since 1994, one dozen of these applications have been performed. An inspection two years later shows the repair to be in great condition.
