# BELZONA REPAIRS SHIPS GENERATOR AFTER WELD REPAIR FAILS

ID: 651

Customer Location: Cruise Line, Port Everglades, Florida  
Application Date: November 2005

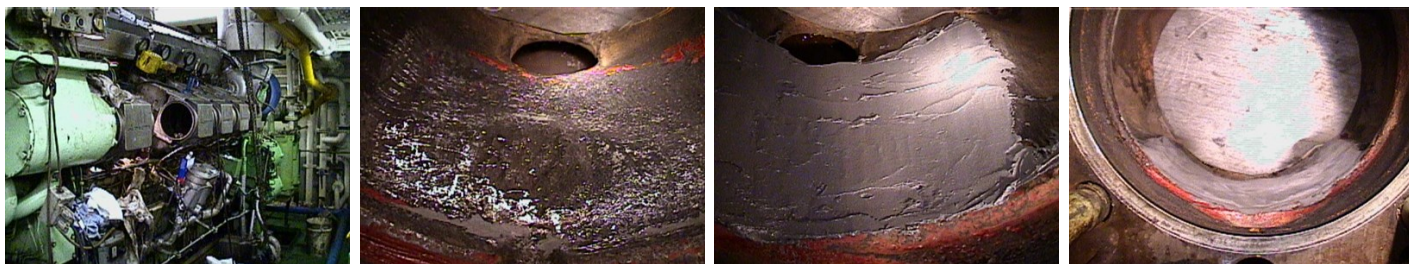
## Photograph Descriptions

*Damaged generator casing allowing coolant into main sump threatening ships main engine bearings.*

- \* Generator with cylinder removed ,
- \* Surface surrounding failed weld roughened ,
- \* Belzona® 1111/9341 patch applied over weld repair and extended onto surrounding area ,
- \* Final repair smoothed out and awaiting Infrared lamp to accelerate cure ,

Main generator oil sump which is shared with ships main engine. Initial weld repair failed.

Classic failure of welding cast iron. Ship sails nightly but re-work completed in 5 hours keeping ship on schedule at full power. Customer is delighted with Belzona!

Application carried out in accordance with Belzona Know-How System Leaflet ENC-1. Particular attention paid to removing all substrate contamination using solvent washing and heat.
