BELZONA REPAIRS BROKEN EDGES OF ENGINE BLOCK

ID: 653

Customer Location: Oil production company, Egypt
Application Date: September 2005

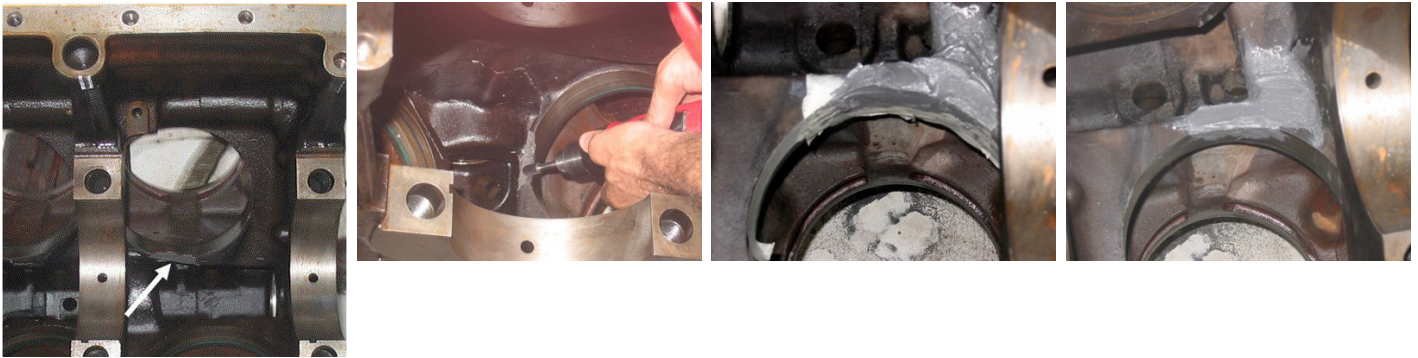
Photograph Descriptions

The edge of the engine block was broken.

- * The broken edge of the block ,
- * Surface preparation ,
- * Rebuilding the broken edge using Belzona® 1111 ,
- * Block was repaired ,

Application was carried out in accordance with Belzona Know-How System Leaflet ENC-1.

Belzona easily repaired the broken edge of the block without heat distortion in only one hour of work.
