BELZONA® 1341 STANDS THE TEST OF TIME AT IRRIGATION PLANT

Customer Location: Irrigation Plant, North Queensland,
Australia

Application: CEP-Centrifugal Pumps

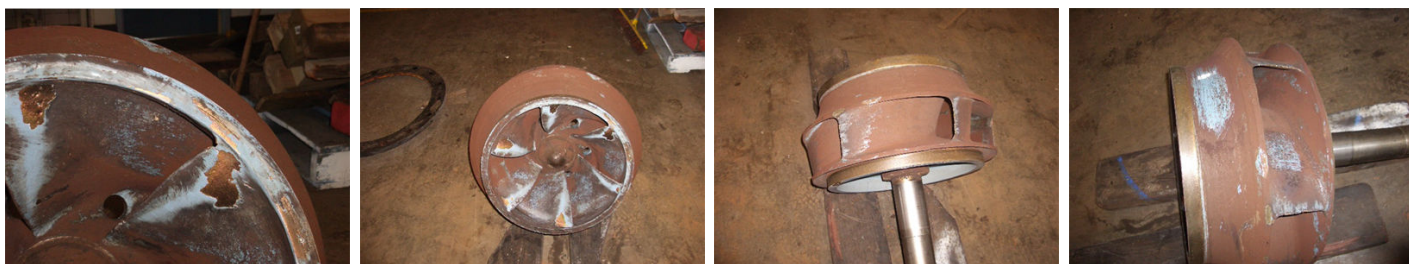
Due to general erosion/corrosion to this impellor, the customer requested sacrificial coating to protect the equipment.

- * Close up of the impellor, showing localised cavitation damage ,
- * The impellor easily patch repaired with Belzona® 1341 ,
- * Deposits from the river water evident on the Belzona coating ,
- * The deposits removed easily with a paper towel ,

Recent inspection of the impellor revealed, that after 12 years of hard work following the Belzona® 1341 application, wear is minimal. Although there is a brown deposit left on the impellor from the river, it is very easily removed with a paper towel.
