BELZONA CATION LINING REPAIR

Industry: Oil & Gas
Application: TCC-Tanks and Chemical Containment Areas
Substrate: Rubber, and Carbon steel.
Products: * Belzona® 2121 (D&A Hi-coat Elastomer) ,

Customer Location: Oil production company , Egypt
Application Date: October 2005.

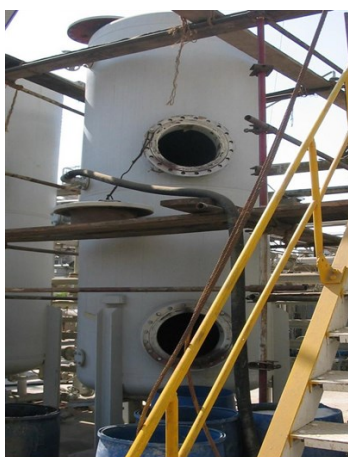
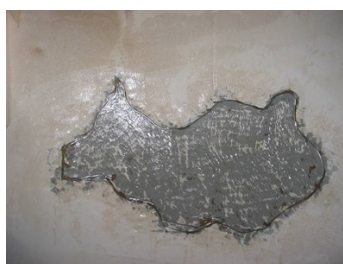
The rubber lining of the cation had deteriorated and had been lost in many places.

- * General view of the Cation ,
- * The perished areas inside the cation ,
- * Surface preparation ,
- * Belzona® 2121 applied ,

Application was carried out in accordance with modified version of Belzona Know-How System leaflet TCC-3.

Many other coatings and solutions had failed before the use of Belzona® 2121 which was chosen due to its excellent chemical

resistance to the regeneration chemicals and for its excellent adhesion.
