BELZONA CATION LINING REPAIR

ID: 658

Cation exchange vessel in the water treatment station.

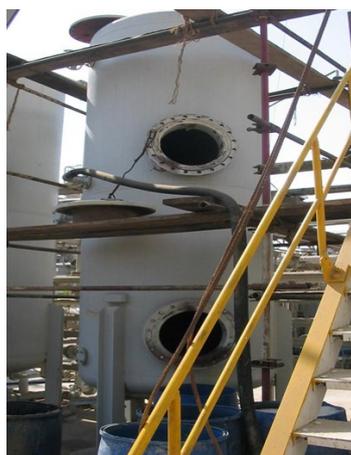
The rubber lining of the cation had deteriorated and had been lost in many places.

- * General view of the Cation ,
- * The perished areas inside the cation ,
- * Surface preparation ,
- * Belzona® 2121 applied ,

Application was carried out in accordance with modified version of Belzona Know-How System leaflet TCC-3.
