# BELZONA CATION LINING REPAIR

ID: 658

**Customer Location:** Oil production company , Egypt  
**Application Date:** October 2005.

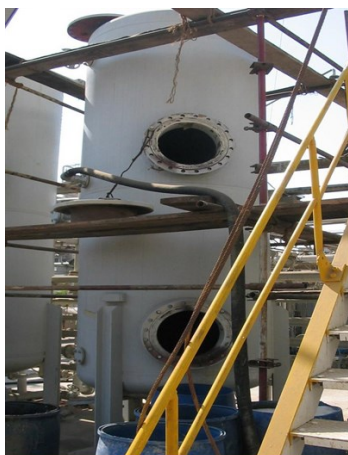
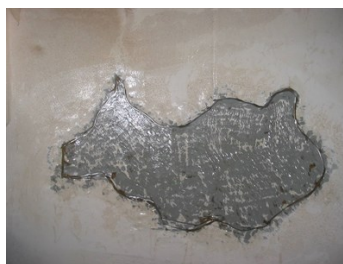
*The rubber lining of the cation had deteriorated and had been lost in many places.*

- \* General view of the Cation ,
- \* The perished areas inside the cation ,
- \* Surface preparation ,
- \* Belzona® 2121 applied ,

Application was carried out in accordance with modified version of Belzona Know-How System leaflet TCC-3.

Many other coatings and solutions had failed before the use of Belzona® 2121 which was chosen due to its excellent chemical

resistance to the regeneration chemicals and for its excellent adhesion.
