BELZONA REPAIRED DAMAGED MIXER AGITATOR DRIVESHAFT AND KEYWAYS

Mixer agitator driveshaft and keyways

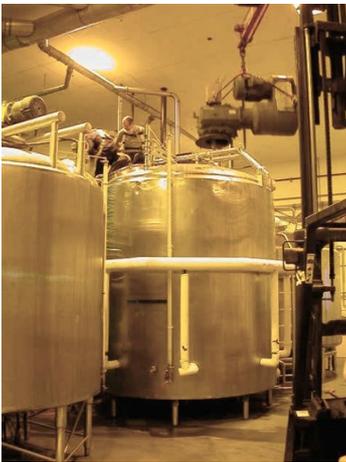
- * 1. Mixing tank ,
- * 2. Damaged drive shaft ,
- * 3. Agitator socket ,
- * 4. Ready for assembly ,

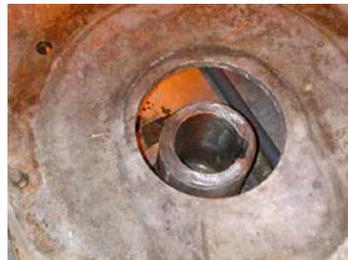
Acid damaged shaft lost 1/2" on the diameter, keyway and key were destroyed. Socket keyway was minimally damaged, but needed to be tightened up. Obsolete drive was built in 1965 and the MFG has been sold twice. Therefore, no parts or prints are available. Mixer shut down. It was imperative that it would be operated in only two days.

The application was carried accordance to the modified version of Belzona Know-How leaflet system MPT-2. Belzona 1111 was used

to build up the shaft diameter and also applied inside the socket and around the new key to fill the keyways. While still wet, the shaft was carefully dropped into the agitator socket keeping the key tight in both keyways.
