BELZONA REPAIRED DAMAGED MIXER AGITATOR DRIVESHAFT AND KEYWAYS

ID: 659

Mixer agitator driveshaft and keyways

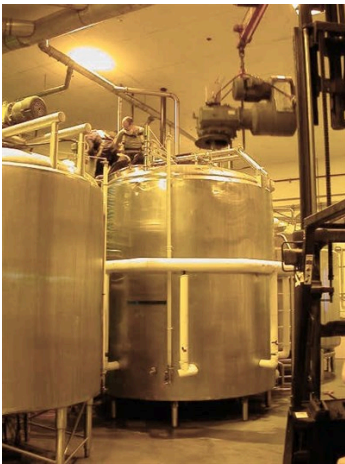
- * 1. Mixing tank ,
- * 2. Damaged drive shaft ,
- * 3. Agitator socket ,
- * 4. Ready for assembly ,

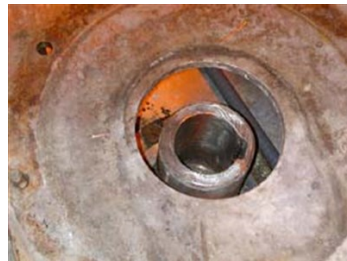
Acid damaged shaft lost 1/2" on the diameter, keyway and key were destroyed. Socket keyway was minimally damaged, but needed to be tightened up. Obsolete drive was built in 1965 and the MFG has been sold twice. Therefore, no parts or prints are available. Mixer shut down. It was imperative that it would be operated in only two days.

The application was carried accordance to the modified version of Belzona Know-How leaflet system MPT-2. Belzona 1111 was used

to build up the shaft diameter and also applied inside the socket and around the new key to fill the keyways. While still wet, the shaft was carefully dropped into the agitator socket keeping the key tight in both keyways.
