# BELZONA BUND SEALING TO ENSURE ENVIRONMENTAL COMPLIANCE

**Industry:** Commercial Facilities  
**Application:** TCC-Tanks and Chemical Containment Areas  
**Substrate:** Concrete  
**Products:** \* Belzona® 4141 (Magma-Build) ,  
\* Belzona® 4131 (Magma-Screed) ,  
\* Belzona® 5231 (SG Laminate) ,

**Customer Location:** Commercial Vehicle Repair Shop  
**Application Date:** September 2005

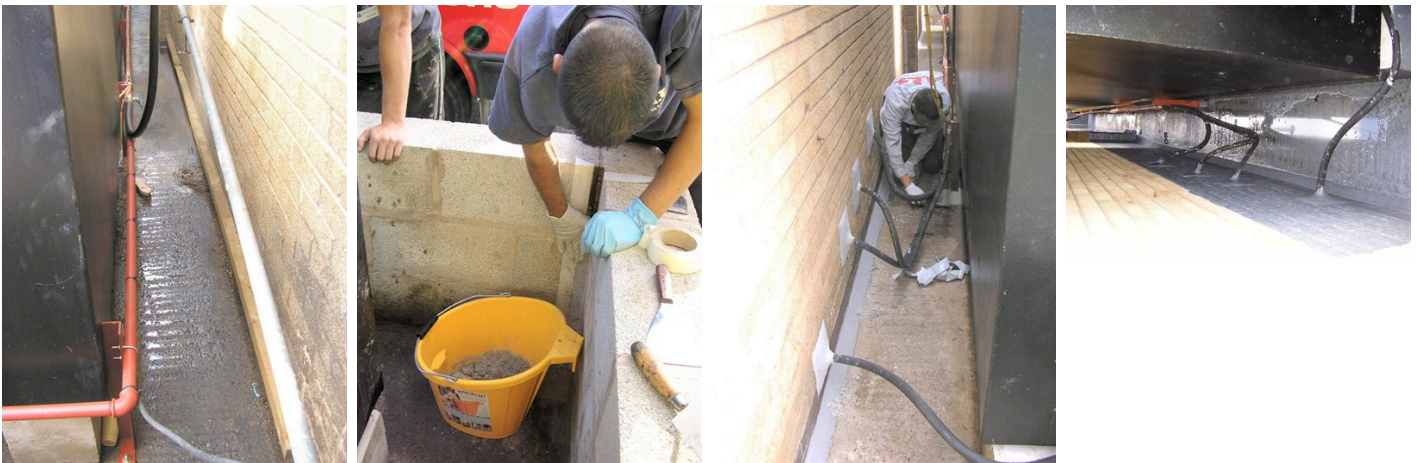
Legislation non-compliance due to newly constructed bund being porous due to construction materials, concrete base and 9 inch concrete block walls.

- \* Porous bund floor and side wall ,
- \* Introduction of wall to wall fillets ,
- \* Wall penetrations sealed and fillet complete ,
- \* Finished job ,

Original condition of bund meant that it failed the Environmental compliance guidelines (PPG 2). Belzona materials were easily applied to give a long term impermeable coating system.

Application carried out in accordance with Belzona Know-How System Leaflet TCC-15.
