BELZONA REPAIR WORN CATERPILLAR FRONT LOADER ARMS

ID: 667

Customer Location: Separation Mine, Skopje, Macedonia
Application Date: November 2005

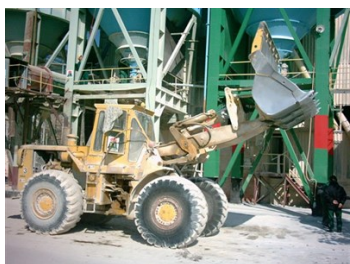
- * Caterpillar front loader ,
- * Close up of the damage ,
- * Repair in progress ,
- * Finished repair ,

Caterpillar front loader bucket arms

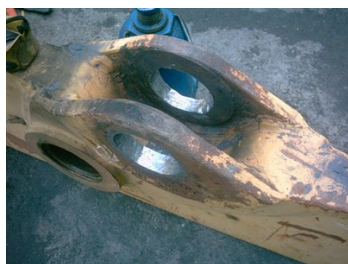
The pivot points for the buckets hydraulic rams had become very worn and were no longer serviceable.
