# BELZONA REPAIR WORN CATERPILLAR FRONT LOADER ARMS

ID: 667

Customer Location: *Separation Mine, Skopje, Macedonia*  
Application Date: *November 2005*

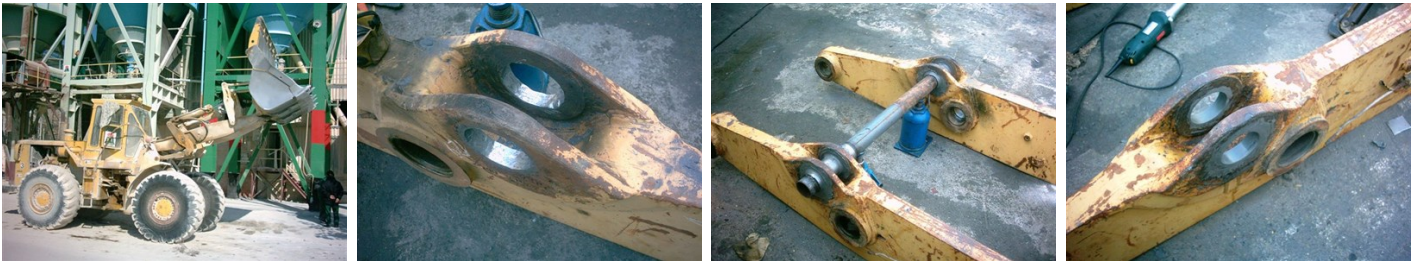
*The pivot points for the buckets hydraulic rams had become very worn and were no longer serviceable.*

- \* Caterpillar front loader ,
- \* Close up of the damage ,
- \* Repair in progress ,
- \* Finished repair ,

Application was carried out in accordance with Belzona Know-How System Leaflet MPT-8.

The Belzona repair was chosen because it was easier, cheaper and faster than conventional methods (welding or replacement) ensuring that the front loader was back into service very much quicker and at a fraction of the cost of replacing the arms.
