BELZONA REPAIR WORN CATERPILLAR FRONT LOADER ARMS

ID: 667

Customer Location: Separation Mine, Skopje, Macedonia
Application Date: November 2005

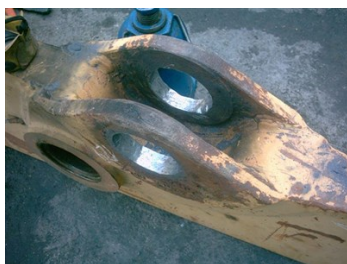
The pivot points for the buckets hydraulic rams had become very worn and were no longer serviceable.

- * Caterpillar front loader ,
- * Close up of the damage ,
- * Repair in progress ,
- * Finished repair ,
