BELZONA REPAIRS LARGE HYDRAULIC RAM

ID: 668

Customer Location: Hot Roll Mill for Steel Sheets, Macedonia
Application Date: October 2005

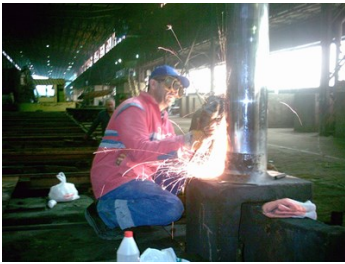
Many years in service had caused large vertical gouges to be worn into the ram

- * Surface preparation ,
- * Ready for application of Belzona ,
- * Finished repair ,

Application was carried out in accordance with Belzona Know-How System Leaflet MPT-3.
